HOUSE CALLS INSPECTION, LLC

Property Inspection Report

Property address: **414 Stone Ridge Dr.
Hixson, TN. 37343**

Inspection date: **2/22/2012**

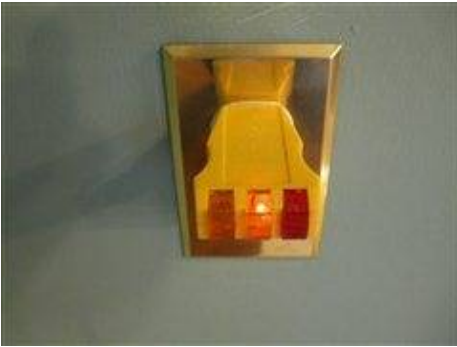
Photo 64

1) *Safety, Repair/Replace, Evaluate* - One or more open ground, three-pronged electric receptacles were found. This is a safety hazard due to the risk of shock. A qualified electrician should evaluate and make repairs as necessary. For example, replacing receptacles or correcting wiring circuits. The rear deck receptacle has an open ground. The rear outside receptacle has an open neutral.

Grounding type receptacles began being required in residential structures during the 1960s. Based on the age of this structure and the presence of 2-pronged receptacles in some areas of this structure, an acceptable repair may be to simply replace the ungrounded 3-pronged receptacles with 2-pronged receptacles. However the following appliances require grounding type receptacles:

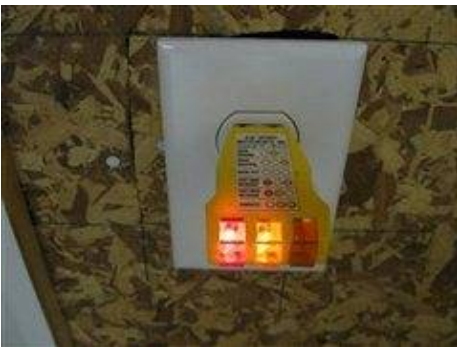
Photo 63

2) *Safety, Repair/Replace, Evaluate* - One or more electric receptacles have reverse-polarity wiring, where the hot and neutral wires are reversed. This is a safety hazard due to the risk of shock. A qualified electrician should evaluate and make repairs as necessary.

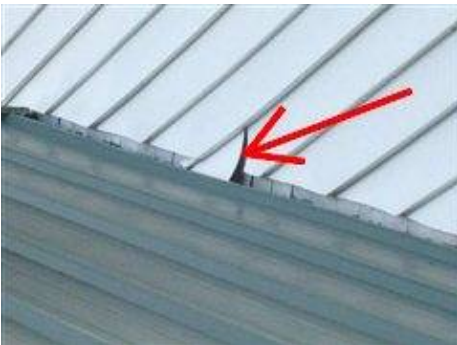
Photo 60

4) *Repair/Maintain, Minor Defect* - A small section of the siding above the garage roof line is broken and partially detached .

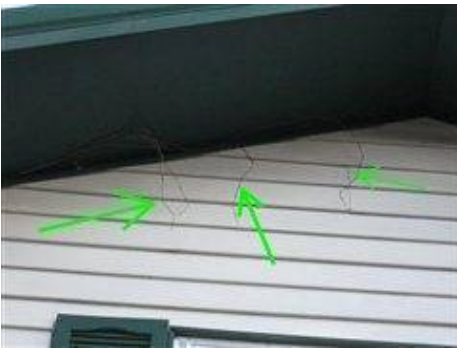
Photo 57

5) *Repair/Maintain, Evaluate, Monitor* - Vegetation is growing up the exterior wall, into the soffit and attic, front right.

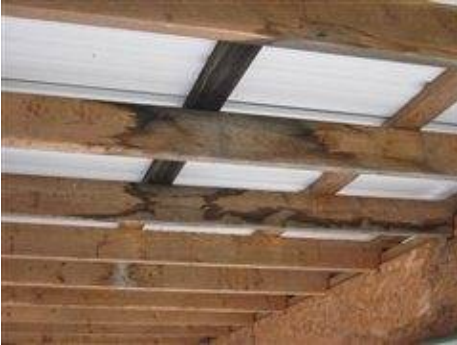
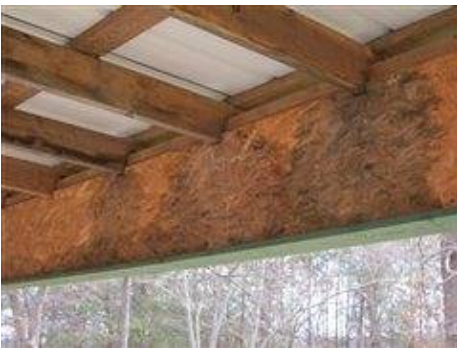
6) *Evaluate, Monitor* - The rear deck joists and the outside beam have water stains. These areas should be monitored to determine if the stains are a current problem.

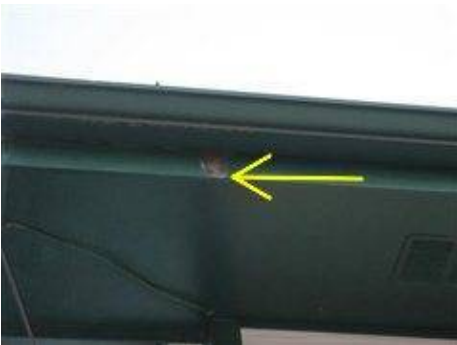
Photo 61

7) *Evaluate, Monitor* - The front gutter has one down spout on the left side, and it appears that there was a down spout on the left side as well. The length of the gutter suggests that the second down spout may be needed.

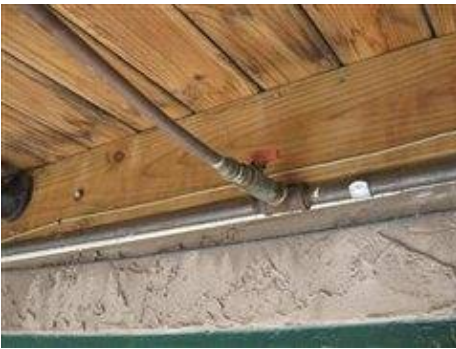
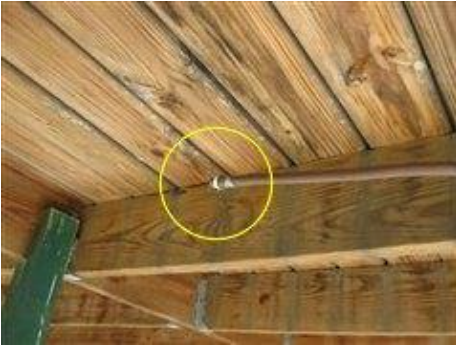
8) - There is a gas line under the rear deck; its appears to have been connected to a grill or some other gas appliance/ device.

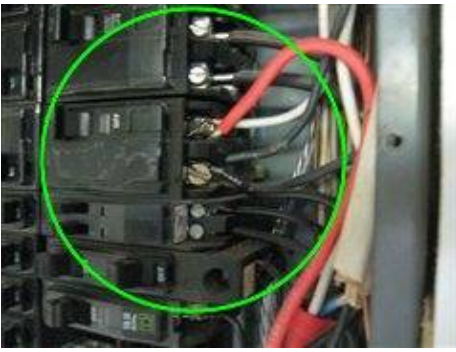
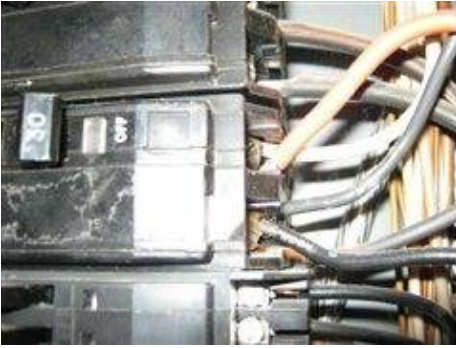
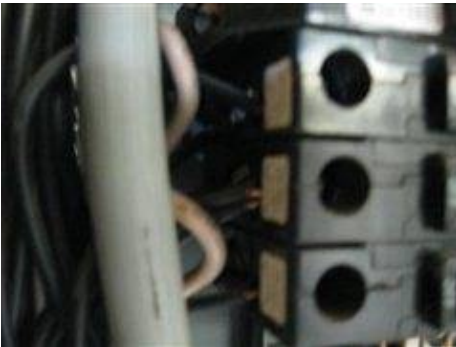
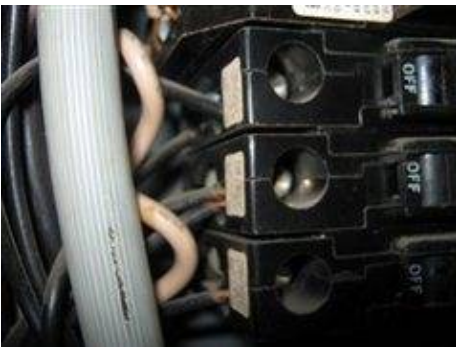
9) *Safety, Repair/Replace, Evaluate* - One or more overcurrent protection devices (circuit breakers or fuses) are "double tapped", where 2 or more wires are clamped in a terminal designed for only one wire. This is a safety hazard since the bolt or screw may tighten securely against one wire, but leave others loose. Arcing, sparks and fires may result. A qualified electrician should evaluate and repair as necessary.

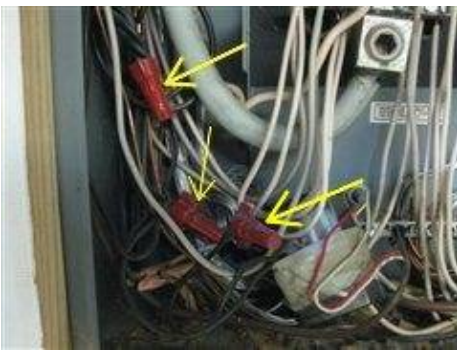
Photo 36

10) *Safety, Repair/Replace, Evaluate* - There are multiple open splices in the service panel

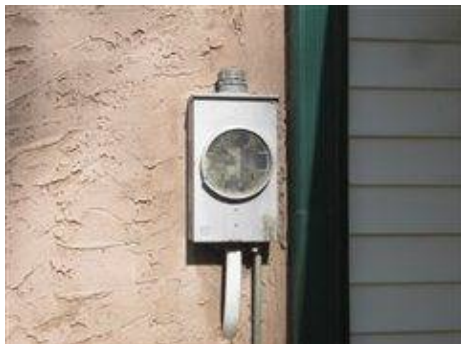
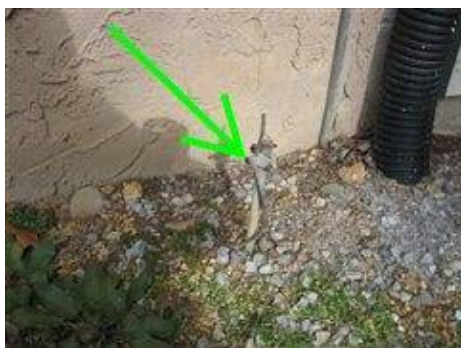
14) - An old meter base and grounding rod are located in the rear.

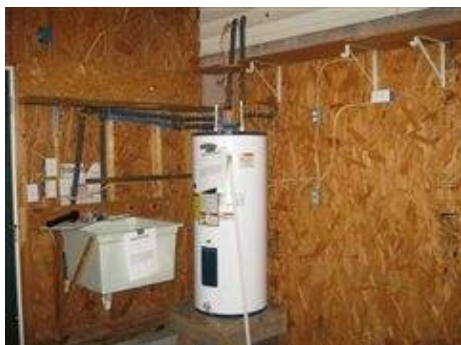
Photo 11

15) - Water heater temperature was 119 degrees F.

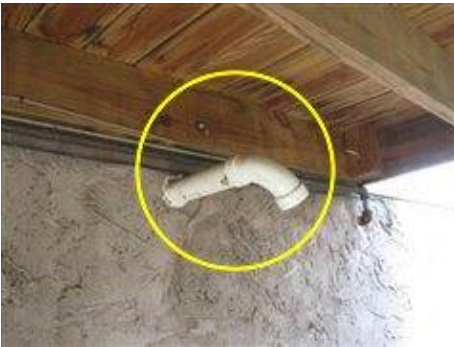
Photo 20

16) *Monitor* - The PVC pipe exiting the rear exterior wall under the deck may be the furnace vent.

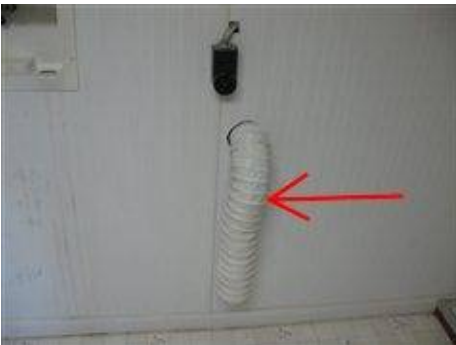
Photo 40

22) *Safety, Repair/Replace* - The existing dryer vent hose should be replaced with a metal unit when the dryer is installed.

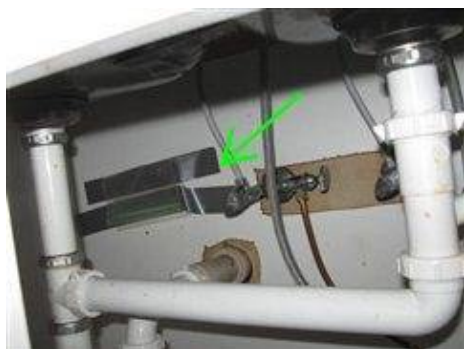
Photo 32

24) *Evaluate, Monitor* - Duck tape is on the wall and one of the pressure lines under the

kitchen sink. The purpose for the tape is unknown. There are no leaks in the plumbing under the kitchen sink.

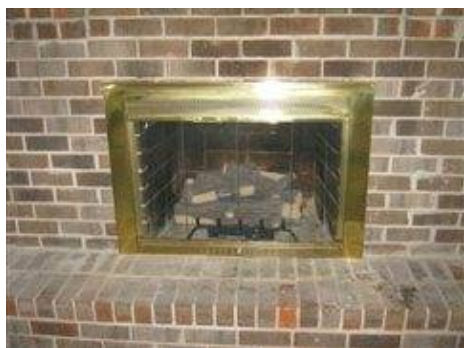
Photo 15

25) *Evaluate* - The gas fireplace insert in the basement was not operational.

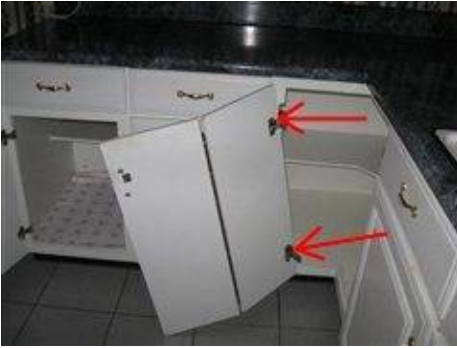
Photo 33

28) *Repair/Replace* - Hardware such as hinges, latches or pulls are loose and/or missing on one or more cabinets. Repairs should be made and/or hardware should be replaced as necessary, and by a qualified contractor if necessary.

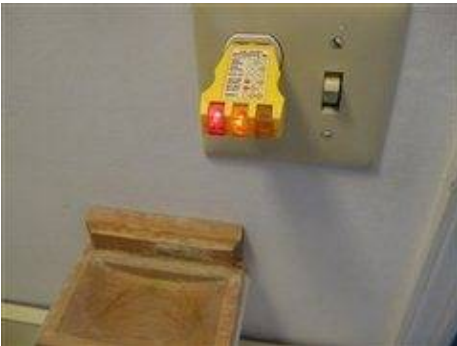
Photo 51

29) *Safety, Major Defect, Repair/Replace* - One of the master bathroom receptacles has reverse-polarity wiring, where the hot and neutral wires are reversed. This is a safety hazard because of the risk of shock. A qualified electrician should evaluate and repair as necessary.

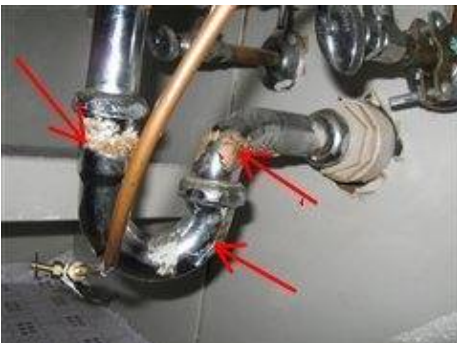
Photo 48

31) *Repair/Replace* - The hall bathroom chrome pipes under the vanity are corroded, and should be replaced.

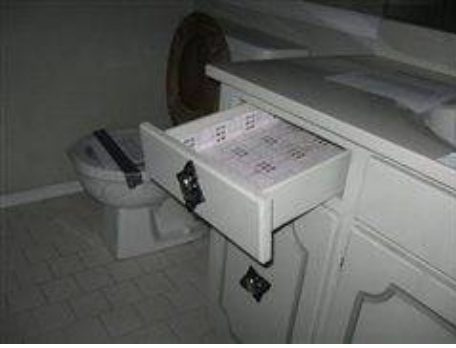
Photo 34

32) *Repair/Maintain, Minor Defect* - One of the main bathroom vanity drawers is off its track

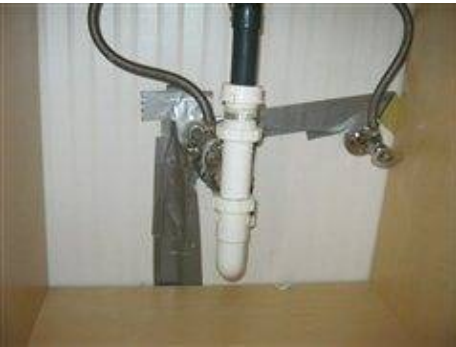
Photo 13

33) *Repair/Maintain, Evaluate, Monitor* - Basement bathroom. The wall behind the vanity has duck tape around the hot water pressure line at its exit from the wall, and there is tape below and to the right side.

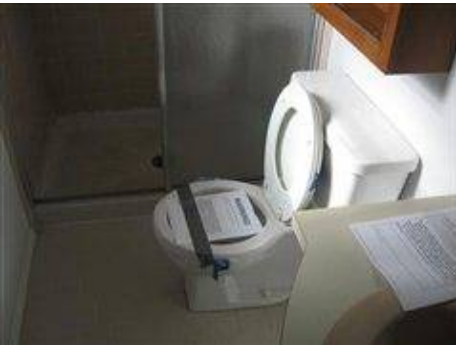
Photo 27

34) *Repair/Maintain, Evaluate* - The main bathroom toilet is slightly loose. The toilet flush is weak.

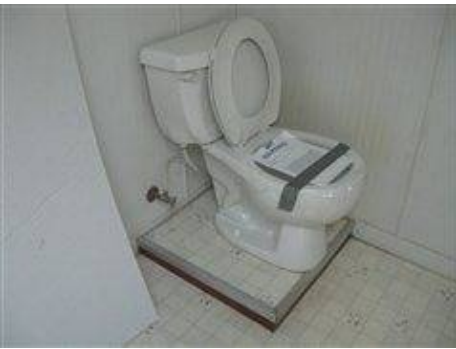
Photo 39

36) *Repair/Maintain, Evaluate* - The basement bathroom toilet is loose.

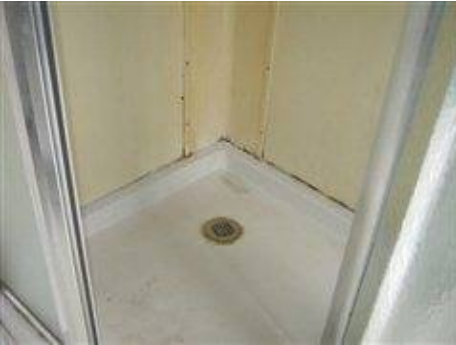
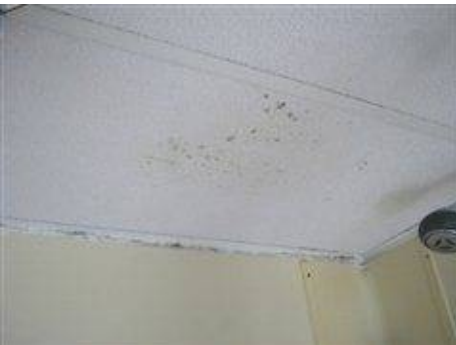
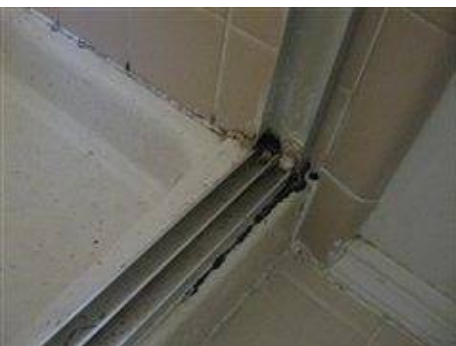
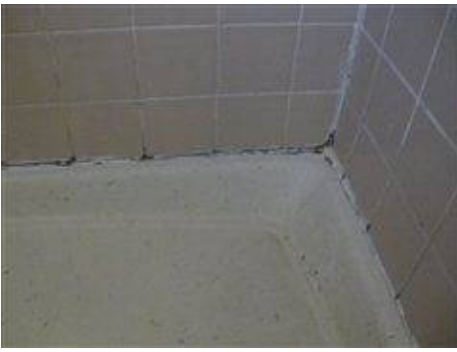
37) *Repair/Maintain* - Caulk is missing or deteriorated around one or more shower surrounds. It should be replaced where deteriorated and/or applied where missing to prevent water intrusion and damage to the wall structure.

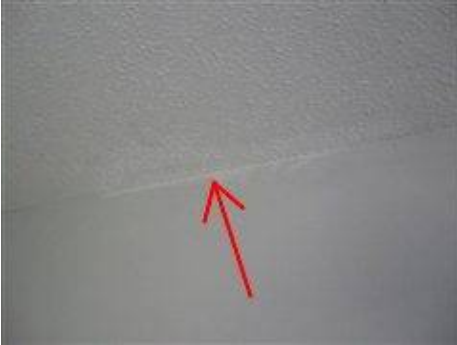
Photo 28

38) *Minor Defect, Monitor* - The ceiling in the master bathroom appears to be patched.

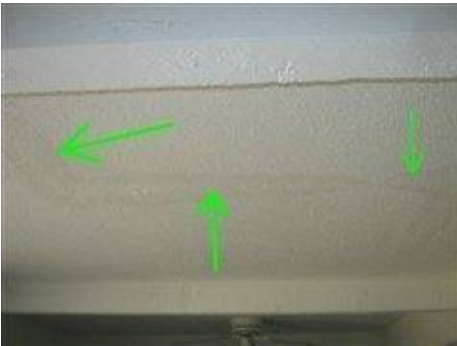
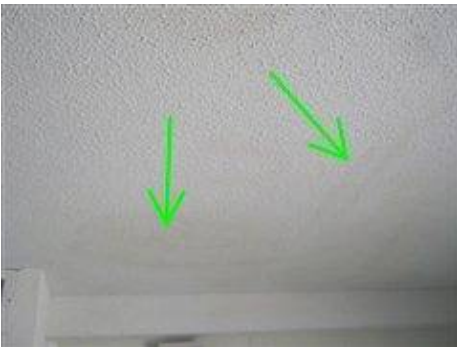
39) *Evaluate, Monitor* - There are water stains on the master bathroom ceiling.

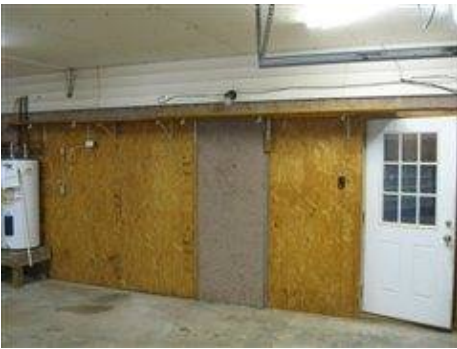
Photo 46

42) *Safety, Repair/Maintain, Evaluate* - There is no firewall between the garage and the living area.

57) *Safety, Repair/Maintain, Evaluate* - The lack of a firewall between the garage and the living area should be evaluated.

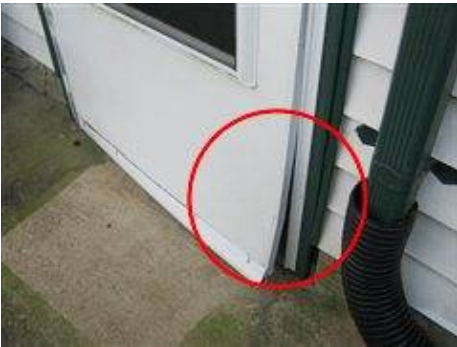
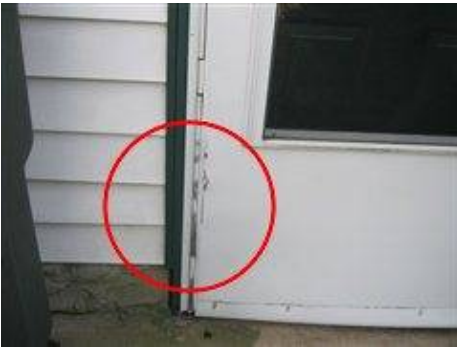
44) *Repair/Replace* - The front exterior garage entrance storm door is warped, and will not fully close.

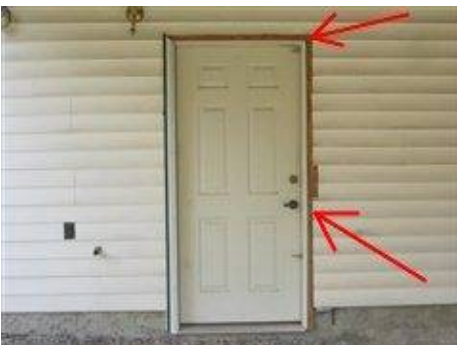
Photo 3

45) *Repair/Replace* - The rear garage door trim/ casing is missing from the top and the right side, exposing the sheathing.

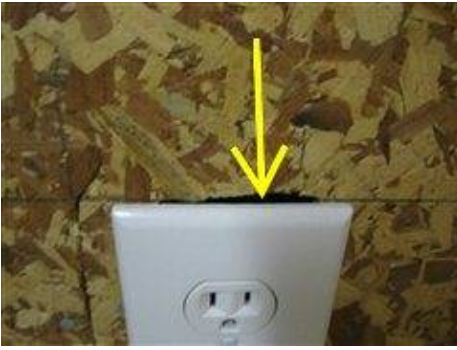
Photo 44

46) *Repair/Maintain, Minor Defect* - There is a small gap above the receptacle behind the

door in the basement storage room.

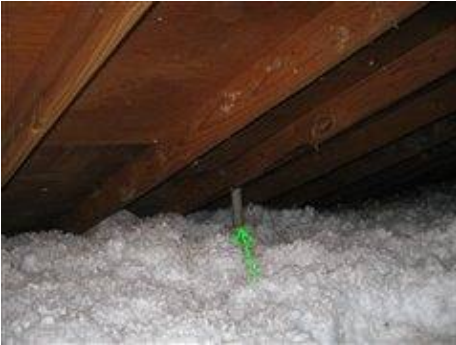
Photo 55

48) - Possible location of the main bathroom vent in the attic. The vent pipe could not be located because of the covering insulation. The vent appears th o be drawing well and may be properly vented to the outside.

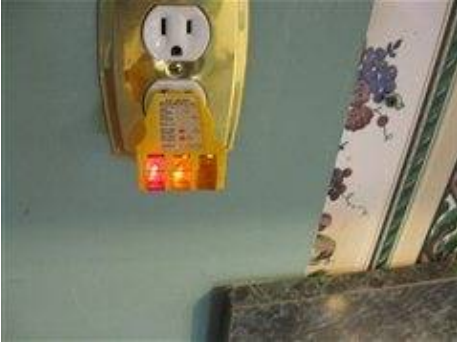
50) *Safety, Repair/Replace, Evaluate* - One or more electric receptacles have reverse-polarity wiring, where the hot and neutral wires are reversed. This is a safety hazard due to the risk of shock. A qualified electrician should evaluate and make repairs as necessary. This receptacle is also loose.

Photo 47
Dining room receptacle

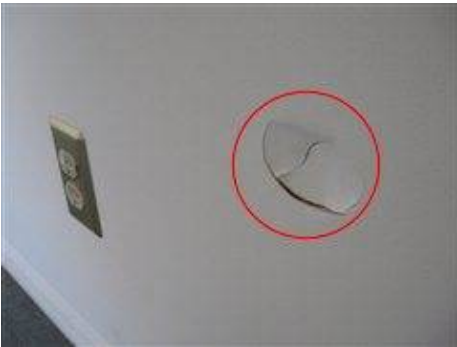
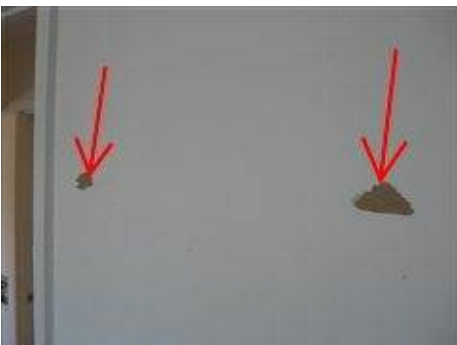
53) *Repair/Maintain, Minor Defect* - The front left bedroom has a small area of damage to the wall sheetrock.

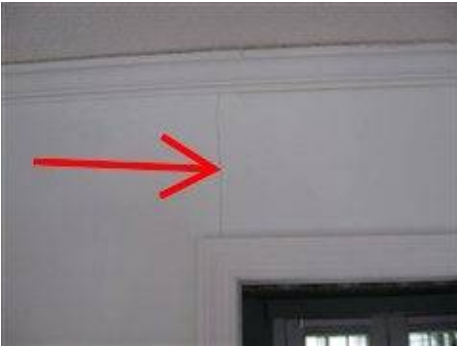
Photo 31

54) *Minor Defect, Monitor* - There is vertical crack in the wall above the door between the living room and dining room.

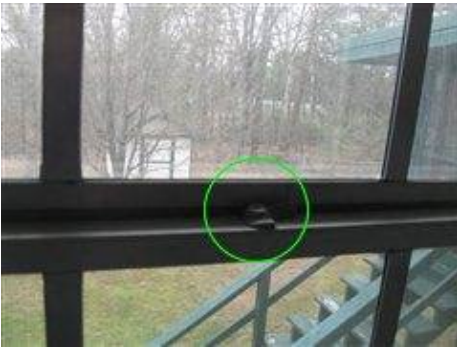
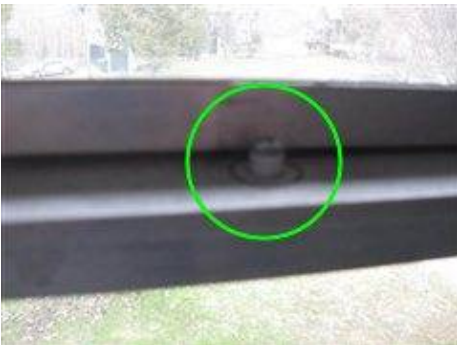
55) - Some of the window latches are broken, upstairs and basement.
