# HOUSE CALLS INSPECTION, LLC

## Property Inspection Report # 121101

**Structure(s) inspected: Residential dwelling; 1 Level**

Property address: **7718 Cove Ridge Dr.**

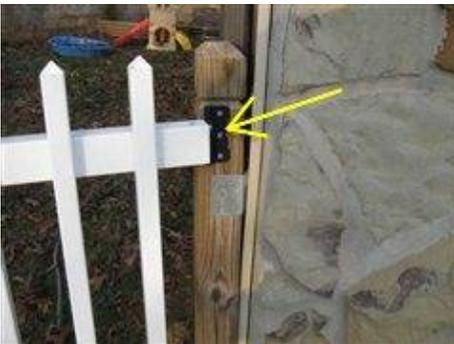
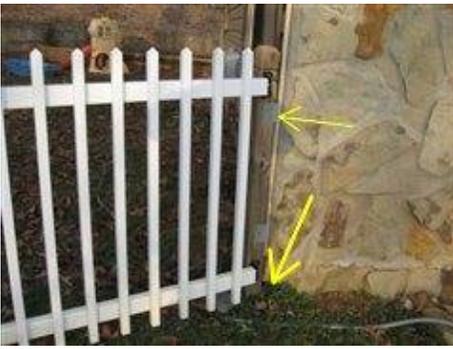
2) *Safety, Repair/Replace* - One or more fence gates are difficult to open, close and/or latch, or are damaged and/or deteriorated. Repairs should be made as necessary, and by a qualified contractor if necessary, so gates operate easily.

The fence gate is attached to the vinyl siding, front left. The gate post is not anchored in the ground, and the entire structure is loose.

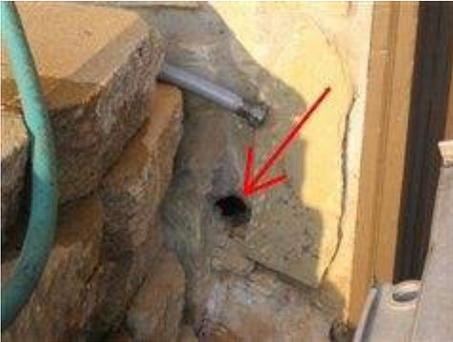
Photo 28

4) *Repair/Maintain* - There is small hole in the stone exterior wall near the garage door. Repair and maintain in order to prevent water, debris and/or vermin intrusion.

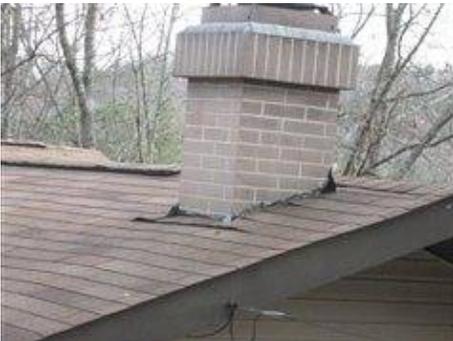
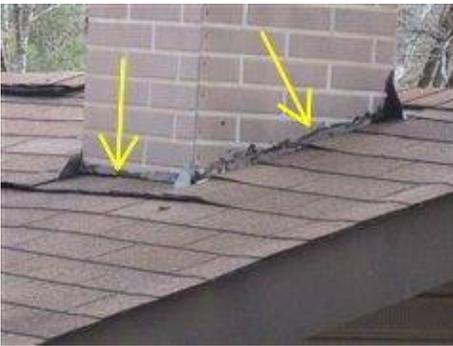
5) *Repair/Replace, Evaluate* - The chimney flashing appears to be installed improperly, and should be checked by a licensed contractor.

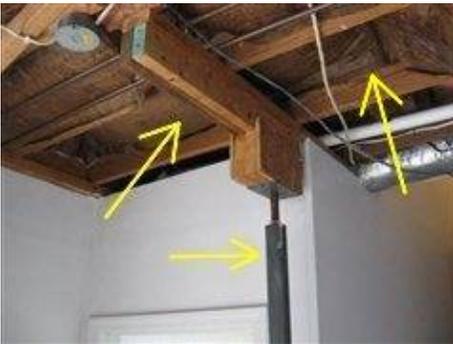
Photo 40

7) *Safety, Repair/Replace, Evaluate* - One or more wall and/or ceiling surfaces between the attached garage and interior living spaces have gaps, holes, or missing or inadequate surface materials. These surfaces are intended to prevent vehicle fumes from entering living spaces, and to slow the spread of fire from the garage to living spaces. A qualified contractor should evaluate and make repairs as necessary so the attached garage wall and ceiling surfaces that adjoin living spaces are tightly sealed and fire rated as per standard building practices. Typically these surfaces require a one-hour fire rating.

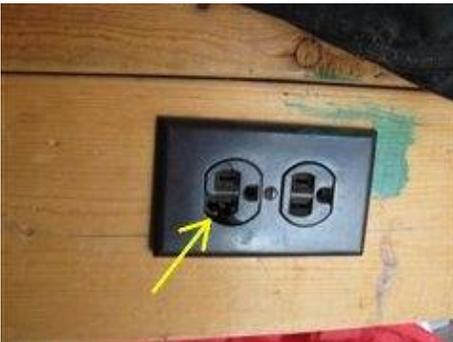
Photo 41

8) *Safety, Repair/Replace* - One of the receptacles is cracked and broken, and should be replaced.

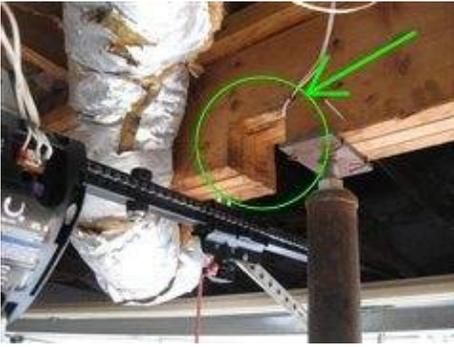
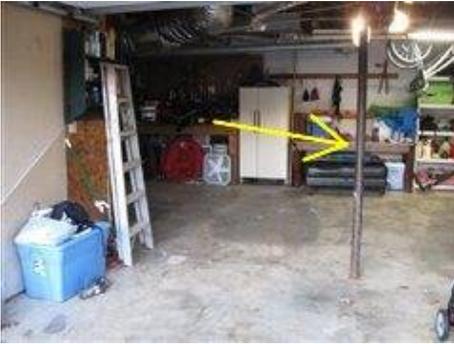
10) *Major Defect, Evaluate* - The main support beam has been notched in the center, and a

metal jack post has been installed for additional support in the center of the garage.

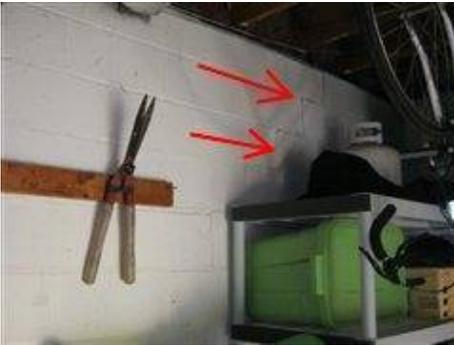
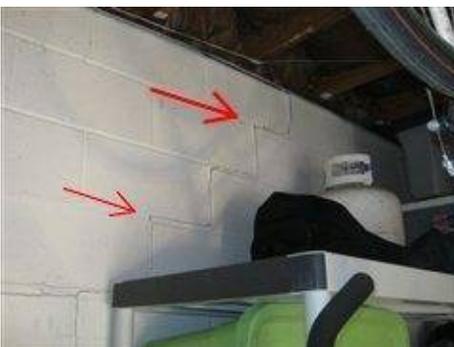
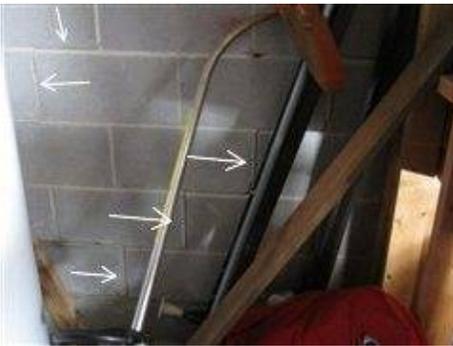
11) *Minor Defect, Monitor* - The rear concrete block wall has a number of step cracks, most of which follow the mortar lines. Most of the cracks are minor, but their condition should be monitored.

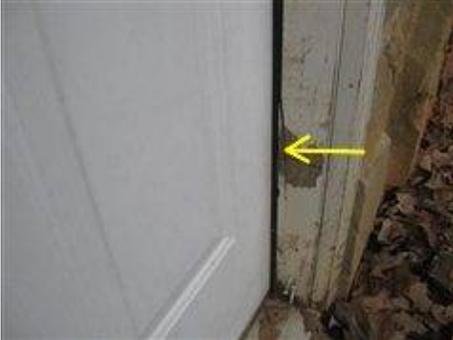
Photo 42

12) *Minor Defect* - The entry door has a small crack in the frame.

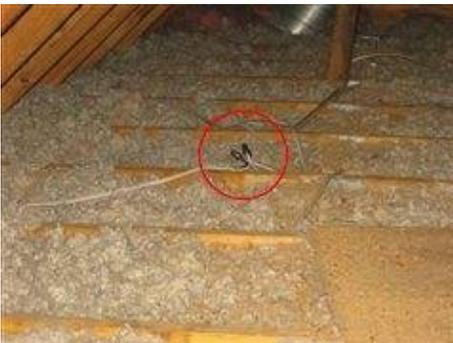
Photo 50

13) *Safety, Repair/Replace, Evaluate* - Wire splices are exposed due to not being contained in a covered junction box. This is a safety hazard due to the risk of shock and fire. A qualified electrician should evaluate and make repairs as necessary. For example, install securely mounted junction boxes with cover plates where needed to contain wiring splices.

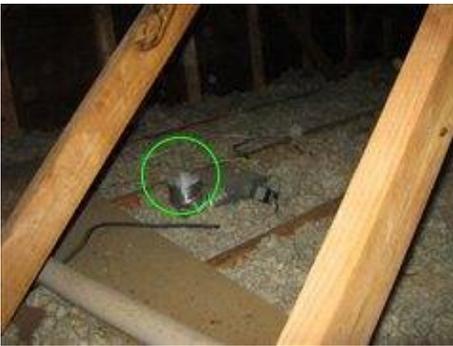
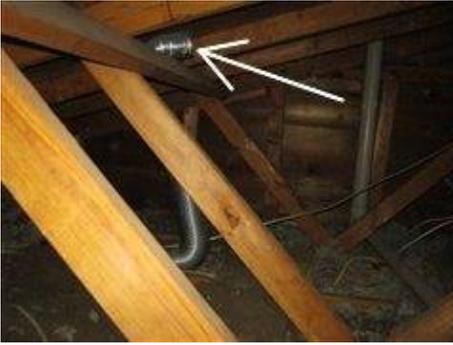
15) *Repair/Maintain, Minor Defect* - Neither of the bathroom exhaust fans is vented properly to the outside.

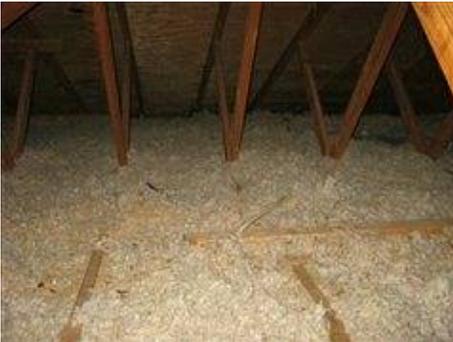
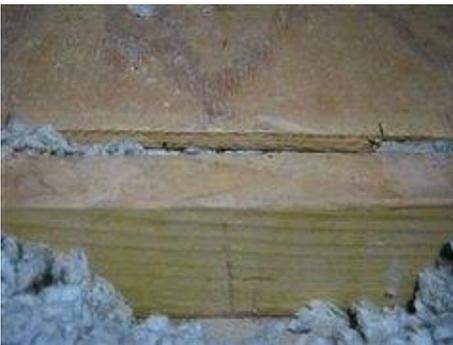
18) *Evaluate* - The attic insulation is inadequate-less than 3" in most areas.

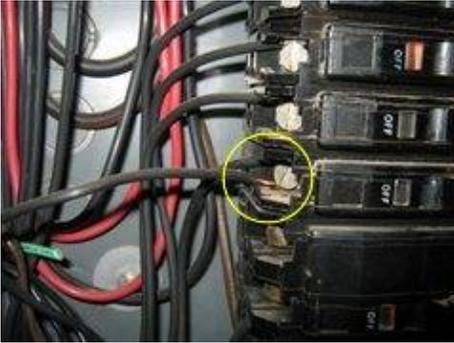
20) *Safety, Repair/Replace, Evaluate* - One or more overcurrent protection devices (circuit breakers or fuses) are "double tapped", where 2 or more wires are clamped in a terminal designed for only one wire. This is a safety hazard since the bolt or screw may tighten securely against one wire, but leave others loose. Arcing, sparks and fires may result. A qualified electrician should evaluate and repair as necessary.

Photo 1  
Main service panel-one circuit breaker has a double tap (two wires connected to the same breaker)

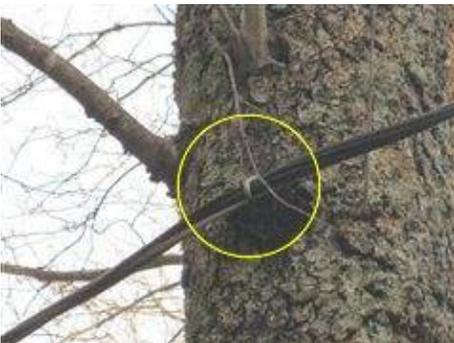
Photo 26

21) *Safety, Repair/Replace* - The service drop wires are in contact with trees or vegetation. Recommend having a qualified tree service company or arborist prune or remove trees as necessary to prevent straining or abrading the service drop wires. The service drop wire has been anchored/ attached to a tree, presumably to raise the height of the wire. Recommend that utility company be contacted to evaluate the problem.

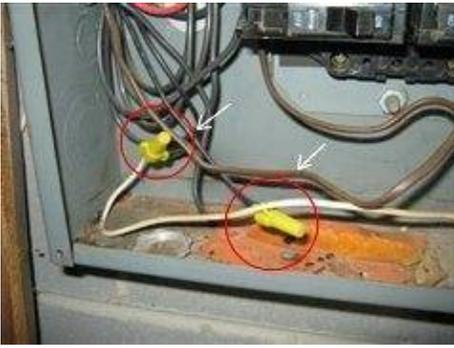
22) *Safety, Repair/Maintain* - There is an open splice inside the main panel. Spliced wiring should be enclosed within a junction box.

Photo 2  
Open splice in the electrical  
service panel.

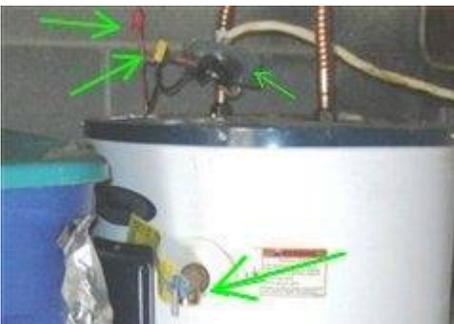
24) *Safety, Repair/Replace, Evaluate* - The unit wiring has an open splice that should be enclosed within a junction box. A qualified electrician should evaluate and repair as necessary.

Photo 49  
( The lower arrow points to  
the pressure relief valve that  
has no extender drain pipe.  
That concern is discussed  
below)

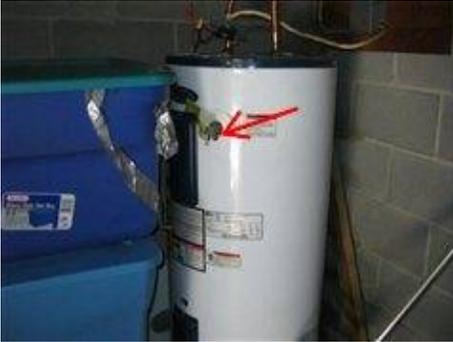
Photo 7

26) *Safety, Repair/Replace* - No drain line is installed for the temperature-pressure relief valve. This is a potential safety hazard due to the risk of scalding if someone is standing next to the water heater when the valve opens. A qualified plumber should install a drain line as per standard building practices. For example, extending to 6 inches from the floor, or routed so as to drain outside.

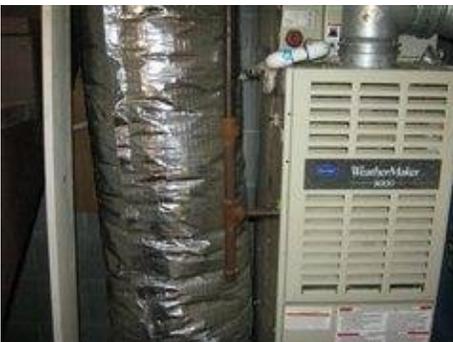
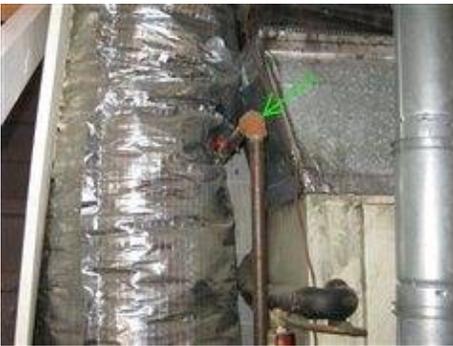
28) *Safety, Repair/Replace, Evaluate* - Some rust and/or corrosion was found on one or more gas supply pipes. Based on this deterioration, the wrong materials may have been used. For example, black iron pipe may have been used where galvanized iron pipe should have been used instead. Leaks may occur as a result. This is a safety hazard. A qualified heating and cooling contractor should evaluate and make repairs as necessary.

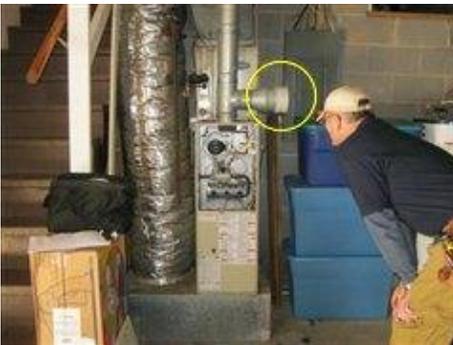
Photo 4

29) *Safety, Repair/Maintain, Evaluate* - The furnace is equipped with a power venting system that does not appear to be vented to the outside. The manufacturer, Field Controls, Inc., indicates on their website that devices outfitted with their units must still be vented outside in order to prevent accumulation of noxious/ dangerous gases within a closed space/ living areas. Recommend that a qualified HVAC technician evaluate the venting system and properly configure it, if necessary.

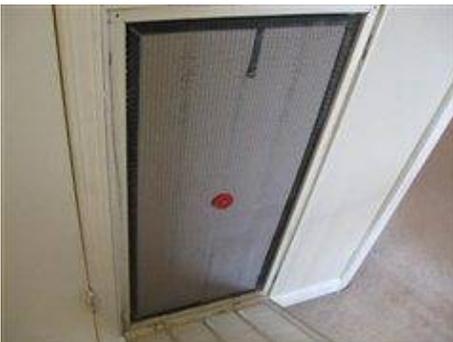
Photo 34

32) *Maintain* - Air handler filter(s) are dirty and should be replaced now. They should be checked monthly in the future and replaced as necessary.

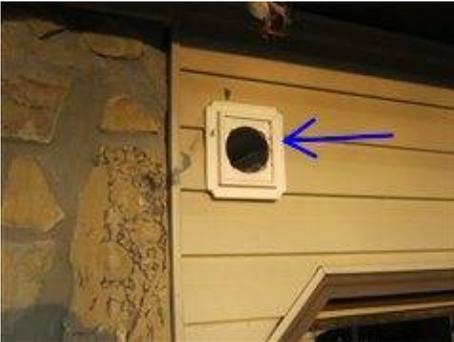
Photo 27

34) *Safety, Repair/Replace, Evaluate* - The clothes dryer exhaust duct is too long, or has too many bends. This may reduce the air flow through the duct, resulting in overheating, reduced efficiency and/or difficulty in cleaning the duct. Standard building practices limit clothes dryer exhaust ducts to 25 feet, and less when bends are present (2.5 feet for each 45-degree bend and 5 feet for each 90-degree bend). A qualified contractor should evaluate and modify the exhaust duct as per standard building practices.

We could only observe the duct between the dryer and the wall (approximately 6" of length), and where the duct terminates above the garage door. There was also no cover on the end of the duct, which prevents intrusion by vermin or debris.

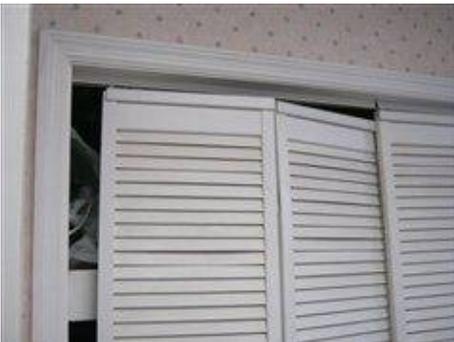
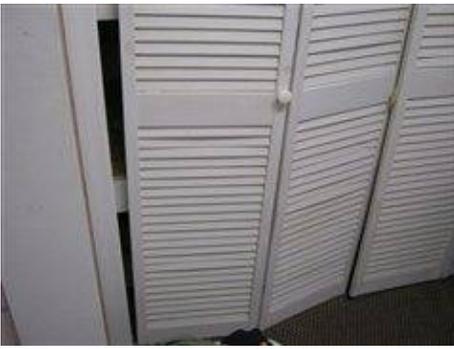
35) *Repair/Maintain, Minor Defect* - One of the laundry room closet doors is partially detached from the frame.

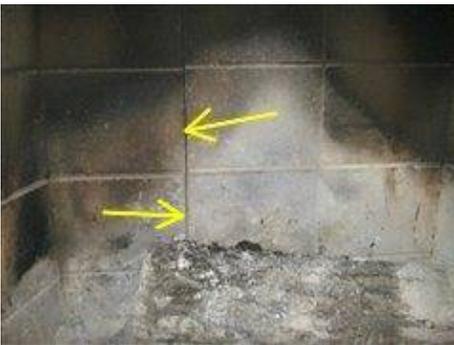
Photo 9

38) *Monitor* - Minor cracks, pitting and/or deterioration were found in some fireplace firebrick. However the bricks were not loose and appear to be serviceable. The clients should monitor the condition of the firebricks in the fireplace's firebox in the future. If significant deterioration occurs or if bricks become loose, then a qualified chimney service contractor should evaluate and make repairs as necessary.

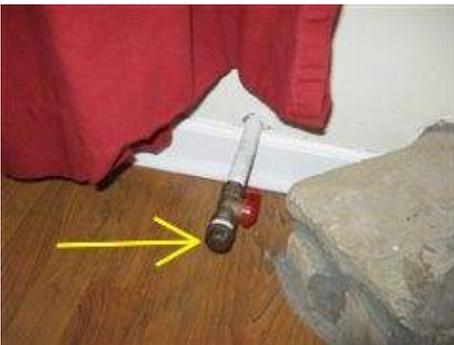
Photo 10

39) *Monitor* - A capped gas supply line, presumably installed for a conversion, extends through the interior wall.

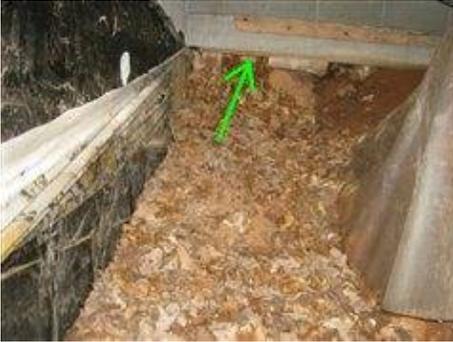
40) *Safety, Repair/Replace* - An opening under the front porch where the exterior wall meets the foundation allows leaves and debris into the deeper crawl space area adjacent to the basement wall. Recommend that the opening be repaired to prevent further intrusions from the outside.

Photo 16  
Inside crawl space.

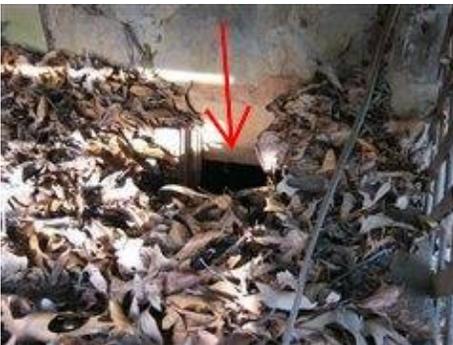
Photo 19  
Under front porch.

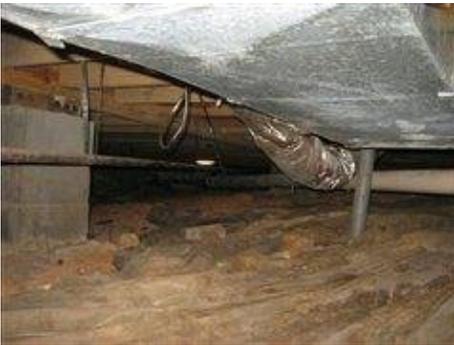
Photo 18

43) *Repair/Replace* - No vapor barrier is installed in some areas. This is a conducive condition for wood destroying insects and organisms due to the likelihood of water evaporating into the structure from the soil. A qualified contractor should install a vapor barrier where missing. Standard building practices require the following:

- The soil below the vapor barrier should be smooth and free from sharp objects.
- Seams should overlap a minimum of 12 inches.
- The vapor barrier should lap up onto the foundation side walls.

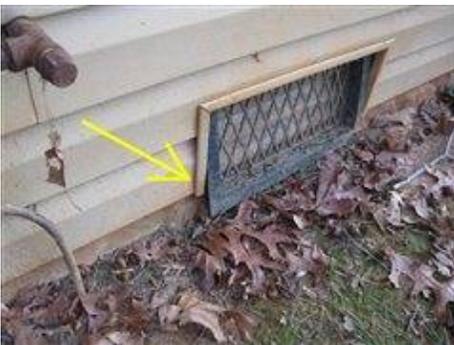
Photo 45

45) *Repair/Maintain, Minor Defect* - One of the crawl space vents, left side, is loose.

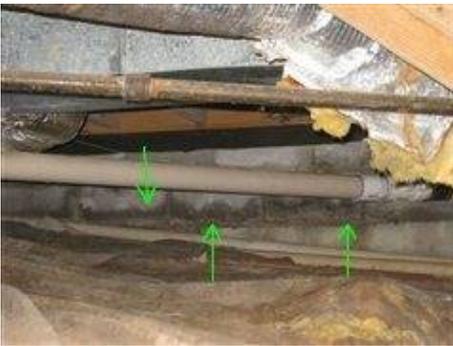
Photo 17

46) *Maintain, Evaluate, Monitor* - The rear crawl space wall has stains that indicate the possibility of past water intrusion. No water, however, was detected in the crawl space.

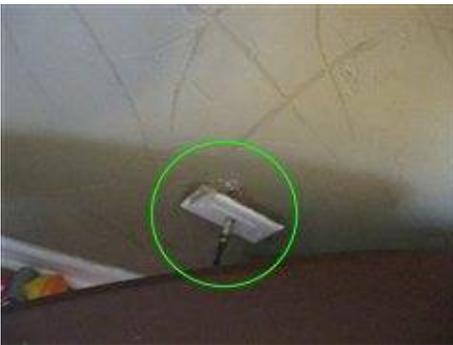
Photo 38

48) *Repair/Replace, Minor Defect* - Dining Room- The cable receptacle is loose.

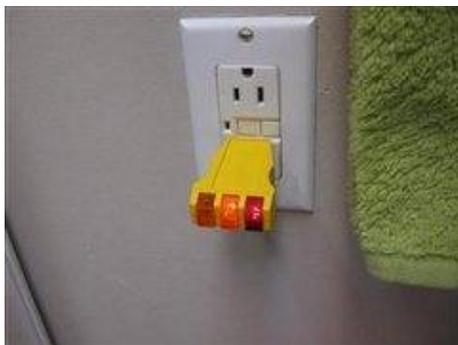
51) *Safety, Repair/Replace, Evaluate* - One or more electric receptacles have reverse-polarity wiring, where the hot and neutral wires are reversed. This is a safety hazard due to the risk of shock. A qualified electrician should evaluate and make repairs as necessary.

Photo 29  
Receptacle above sink.

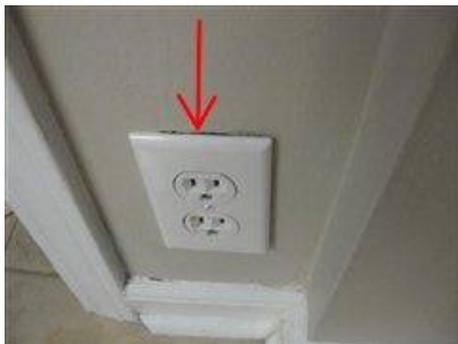
52) *Safety, Repair/Replace, Evaluate* - One or more electric receptacles and/or the boxes they are installed in are loose and/or not securely anchored. Wire conductors may be damaged due to repeated movement and/or tension on wires, or insulation may be damaged. This is a safety hazard due to the risk of shock and fire. A qualified electrician should evaluate and repair as necessary.

Photo 30  
Adjacent to tub.

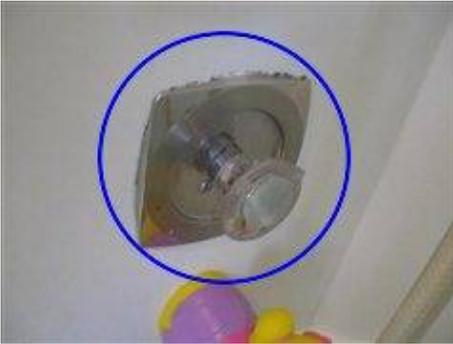
Photo 32

54) *Repair/Replace* - The hall bath faucet and palte is loose and should be repaired or replaced as necessary.

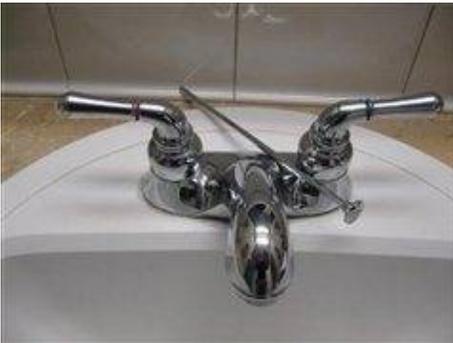
Photo 33

55) *Repair/Replace* - One or more sink stopper mechanisms are missing, or need adjustment or repair. Stopper mechanisms should be installed where missing and/or repairs should be made so sink stoppers open and close easily.

The hall bath sink stopper is not connected.

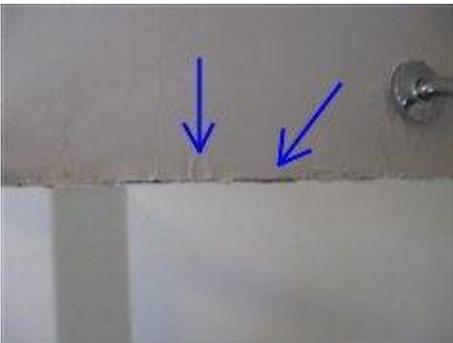
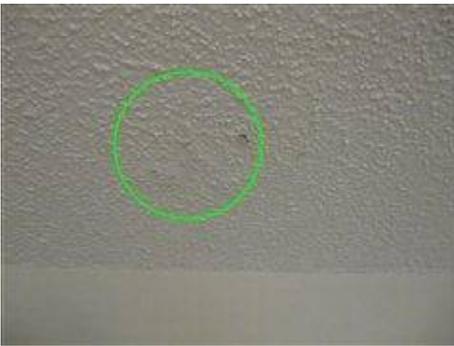
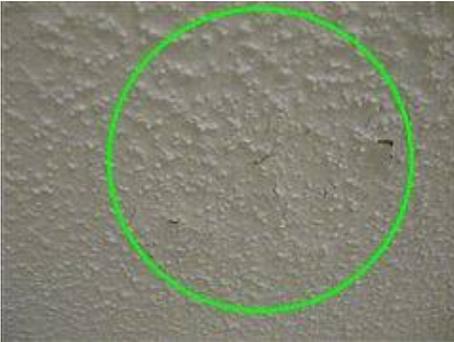
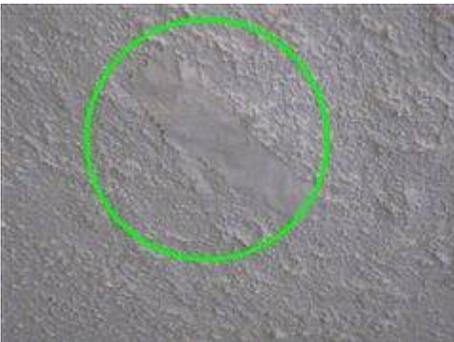
57) *Minor Defect, Monitor* - Both the master and hall bathrooms have small patched or damaged areas, possibly the result of condensation.

Hall bathroom above shower.

Photo 35  
Master bathroom.

Photo 36  
Master bathroom.

Photo 37  
Hall bathroom.

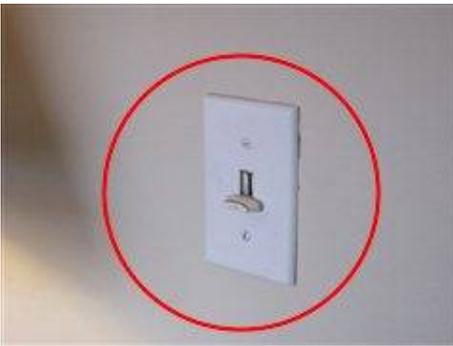
Photo 12

59) *Repair/Replace, Minor Defect* - The dimmer switch in the living room does not appear to be working.

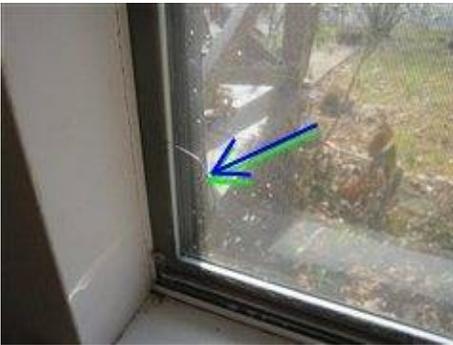
Photo 8

60) *Repair/Replace, Evaluate* - The sash spring mechanism(s) in one or more windows are broken or loose. A qualified contractor or service technician should evaluate and make repairs as necessary so the window(s) operate as intended (open easily, stay open without support, close easily, etc.).

Some of the windows would remain in the raised position, and at least two two windows could not be opened at all without force. One window in the living room is cracked.

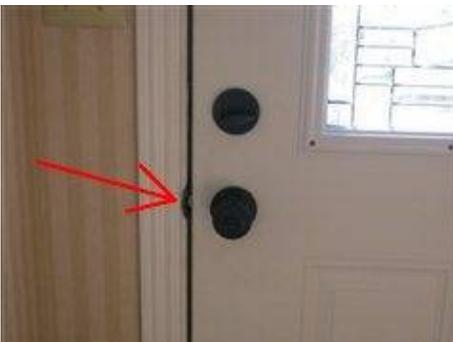
Photo 11

63) *Repair/Replace* - The front entry door will not latch when closed. Repairs should be made as necessary, and by a qualified contractor if necessary. For example, aligning strike plates with latch bolts and/or replacing locksets.

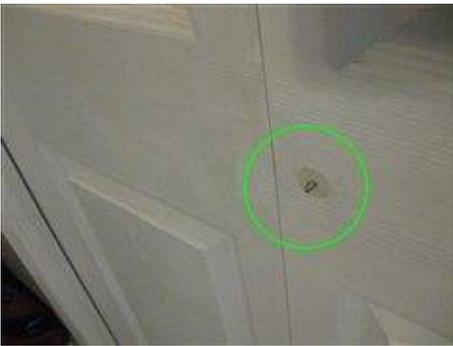
Photo 51

64) *Repair/Replace* - The master bedroom closet door knob is missing.

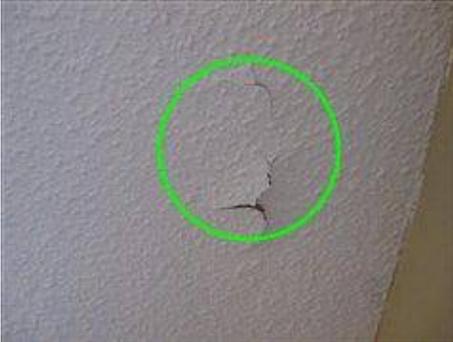
Photo 52

65) *Evaluate, Monitor* - The ceiling in the dining room has a small area of damage, cause unknown.
